## Key Lessons for Preventing Inadvertent Mixing During Chemical Unloading Operations

### Chemical Reaction and Release in Atchison, Kansas

MGPI Processing, Inc.

**No. 2017-01-I-KS**

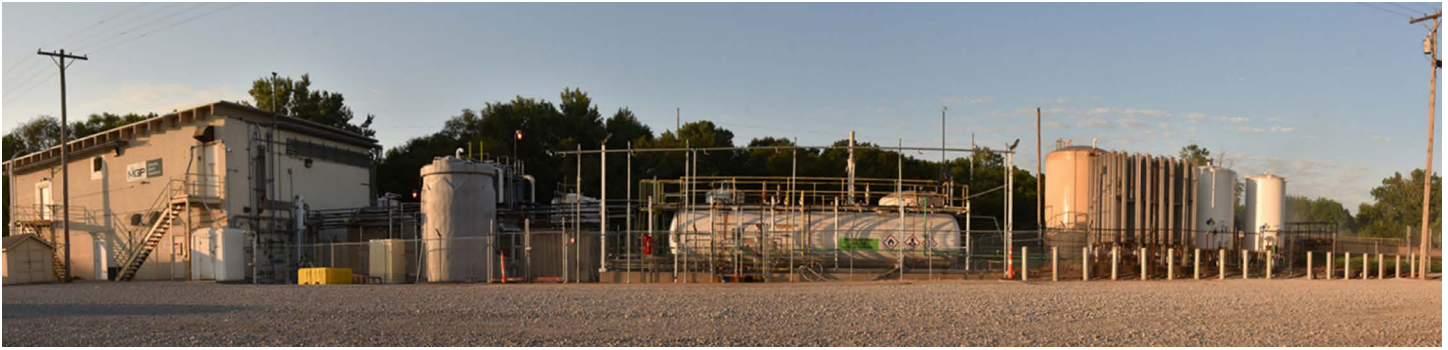
**Figure 1.** MGPI's Mod B facility in Atchison, Kansas (Source: MGPI).

The October 2016 incident occurred at MGPI's Mod B area, where specialty wheat starches are manufactured to customer specifications (Figure 1). At Mod B, different chemicals are utilized to satisfy various desired characteristics of the specialty and commodity starches, including the use of sulfuric acid to modify starch through pH adjustment, and the use of sodium hypochlorite to oxidize starch. The Mod B area, separated from the main plant by railroad tracks, is located on an access road

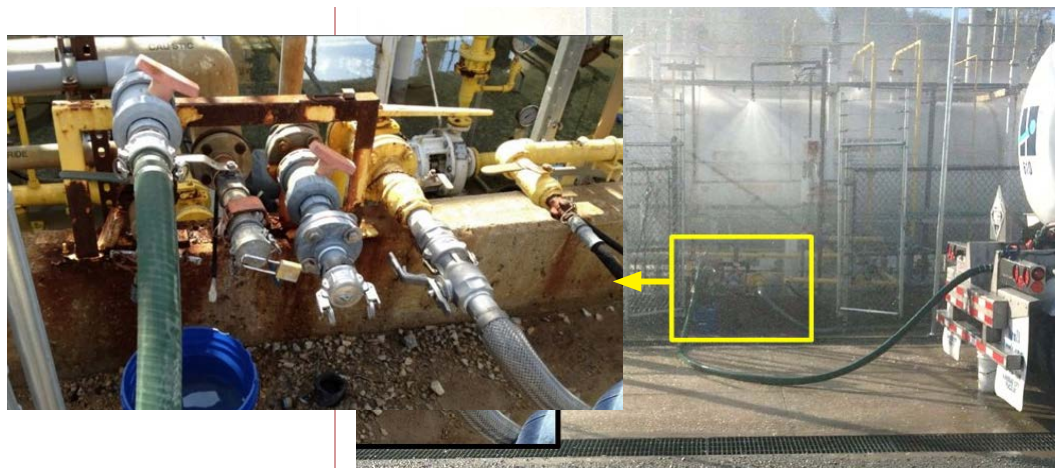
**Figure 4.** Chemical unloading operations at the time of the incident (Source: MGPI).<sup>6</sup>

flow through piping to several large bulk storage tanks in the tank farm (Figure 4). Operators then transfer smaller quantities of the chemicals, as needed, into day tanks and/or process vessels for production inside the Mod B building.

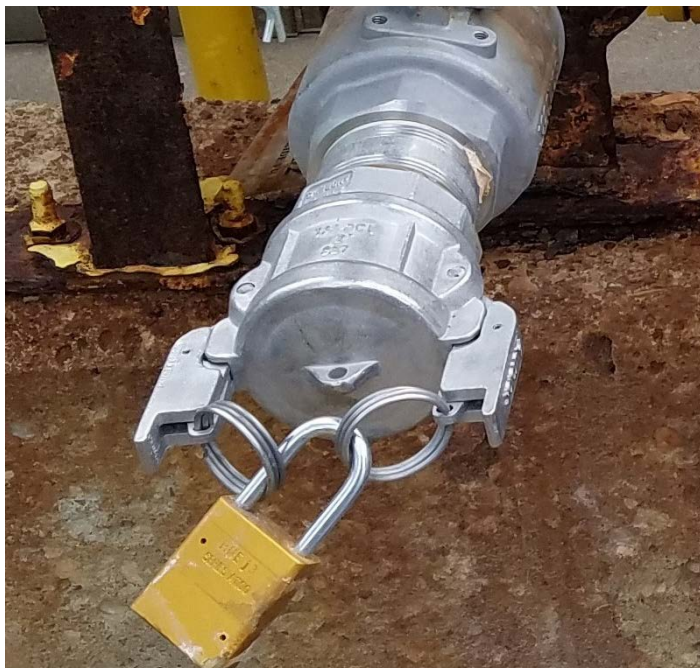
**Figure 5.** A locked cam lever dust cap on a fill line at Mod B (Source: CSB).

To access the fill lines for a chemical delivery, operators first unlock a barbed wire gate that encloses the tank farm area and five fill lines designated for each chemical (Figure 4). Next, operators unlock the padlock on the cam lever dust cap that secures the fill line for the chemical being delivered. Cam lever dust caps prevent access to fill lines by capping the end of the fill lines when they are not in use. As seen in Figure 5, cam lever dust caps are secured by engaging two levers and locking them in place with a padlock and two split rings. CTMV drivers rely on operators to unlock and identify the fill line designated for the chemical being transferred. Operators then show drivers the appropriate fill line. Once the equipment is unlocked, operators return to the control room. Drivers then remove the dust cap and connect their chemical discharge hose from the cargo tank to the fill line. After completing delivery, drivers place the dust cap back on the fill line and re-secure it by locking the padlock. It was, and is, MGPI's practice to unlock fill line dust caps only for delivery.

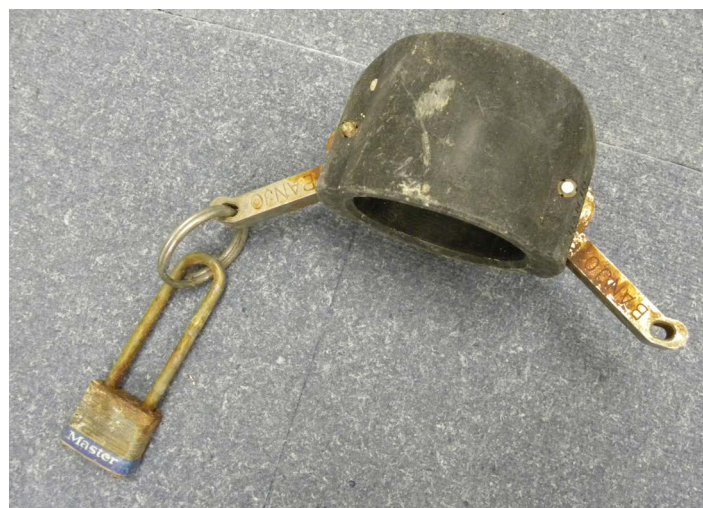
**Figure 7.** Sodium hypochlorite dust cap with missing split ring. The missing split ring prevented the dust cap from being secured by the padlock (Source: CSB).

Although the sulfuric acid dust cap was unlocked immediately prior to unloading, the CSB found that the sodium hypochlorite fill line was also accessible to the driver (Figure 7). The driver connected the sulfuric acid discharge hose to the unsecured fill line for the sodium hypochlorite bulk tank, which resulted in the inadvertent mixing of approximately 4,000 gallons of sulfuric acid and 5,850 gallons of sodium hypochlorite. This mixture of incompatible materials resulted in a reaction that promoted the release of a cloud containing chlorine gas and other compounds (Section 4.0).

unlocked the sulfuric acid dust cap for the delivery. The sodium hypochlorite dust cap was unable to be locked because it was missing a split ring on one lever. Without the split ring on one of the cam levers, it was impossible to secure the dust cap on the

The CSB was unable to determine why the sodium hypochlorite dust cap was missing a split ring nor how long it was left unsecured on the fill line prior to the incident. It is possible that the sodium hypochlorite

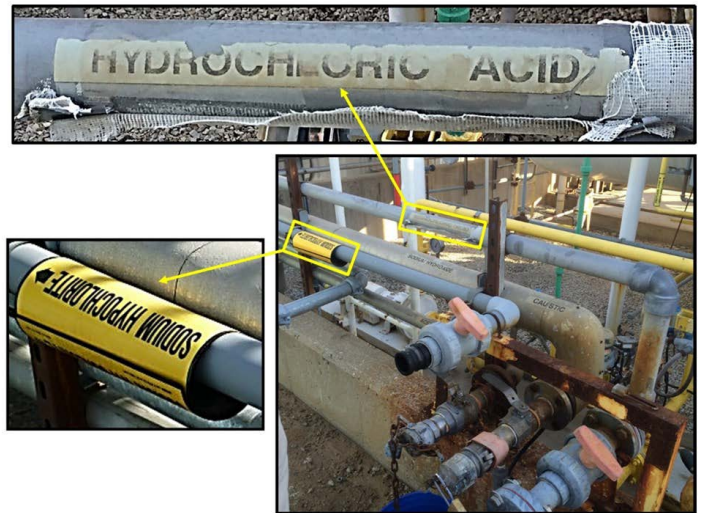
The CSB also found that the placement and orientation of the pipe markings downstream of some of the Mod B fill lines made it difficult for drivers less familiar with the piping arrangement to confirm that they made a correct connection. It is common practice for pipe markers to be placed at multiple points along piping, from start (e.g., connection point) to finish (e.g., tank).<sup>58</sup> These pipe markers must be strategically placed so that they can be easily followed and visually accessible from a normal line of vision<sup>59</sup>; effective placement allows the pipes to be “traced.” The CSB observed pipe markers along the sulfuric acid and sodium hypochlorite piping and found that MGPI did not place pipe markers as close to the fill line connection points as possible. The piping immediately downstream of all the Mod B fill lines changed direction at a 90-degree elbow (Figure 12, right). Both the sodium hypochlorite and sulfuric acid pipe markers were located several feet downstream of the pipe elbow and fill line (Figure 12, right). The recommended industry practice for piping identification states that pipe markers shall be placed adjacent to changes in direction.<sup>60</sup> MGPI selected a sleeve or wrap around marker for the sodium hypochlorite piping that attached loosely to the pipe. In addition, the text of the pipe marker appeared upside down from the vantage point of the fill line area (Figure 12, left). MGPI’s placement and orientation of the sodium hypochlorite pipe marker likely decreased its visibility and readability to the driver when he connected the sulfuric acid hose to the fill line.

**Figure 12.** Sodium hypochlorite pipe marker appearing upside down (left) and sulfuric acid piping mislabeled “hydrochloric acid” from a prior service (top). Both pipe markers are located several feet from the fill line and elbow (right) (Source: CSB).

After the incident, the sulfuric acid fill line was found to be incorrectly identified as “hydrochloric acid” from a prior service (Figure 12, top).<sup>61</sup> Although the CSB found a damaged sulfuric acid pipe marker on the ground approximately 3 feet south of the unloading station and fill lines, it could not be determined whether this pipe marker was adhered to the sulfuric acid fill line prior to the incident.<sup>62</sup>

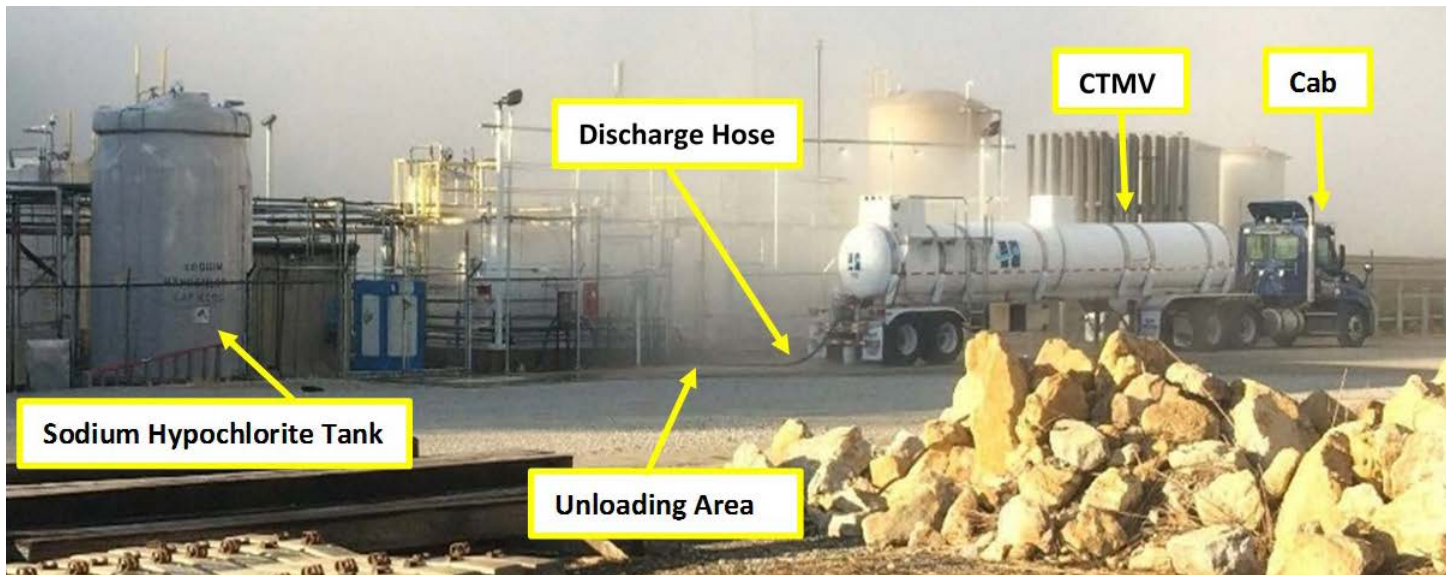
**Figure 15.** Post-incident photograph of Harcros CTMV connected to sodium hypochlorite fill line at Mod B unloading area, showing sodium hypochlorite tank and cab of CTMV (Source: MGPI).

connected his discharge hose to the first fill line he saw unlocked after the operator left the unloading area. He then opened the valves and returned to the cab of the truck. First, the procedure states that drivers must “carefully check to make certain that material to be transferred will be going into the correct vessel.” Second, the procedure states that drivers must “continuously monitor transfer.”<sup>76</sup> The CSB found, however, that the truck driver did not check to ensure the material in the truck would go into the correct vessel, such as by tracing the fill line with the operator or requesting confirmation of a correct connection from the operator before the operator left the unloading area. Furthermore, the truck driver did not continuously monitor the transfer, as he was in the cab of the truck facing away from the unloading area (Figure 15).<sup>77</sup> Had this second step in the procedure been followed, the driver likely would have monitored the unloading operations from an area closer to the back of the truck, thereby allowing him to immediately close either the fill line or truck valve to stop the flow of sulfuric acid.

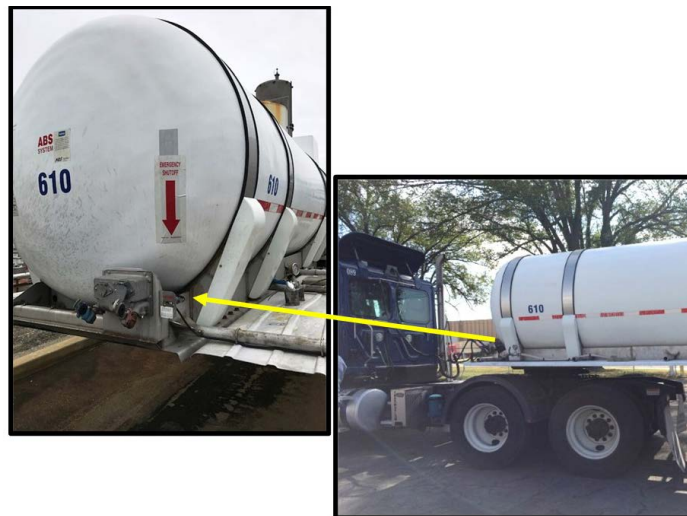
In reviewing Harcros' training documentation, the CSB identified another area that may have contributed to the incident: the tanker training log indicated that the driver was aware of the location of a pneumatic<sup>80</sup> emergency shutoff switch for the internal valve that would stop the flow of product, at the front of the trailer<sup>81</sup>; however, the CSB found that the driver did not trigger the emergency shutoff switch, despite being in the cab at the time of the incident (Figure 16).

**Figure 16.** Harcros CTMV (right) and emergency shutoff switch (left) (Sources: Harcros and CSB).

and 49 C.F.R. § 172.704(c)(2). Accordingly, drivers should be intimately familiar with the location of emergency remote shutoffs, as well as with how they function. Had Harcros provided adequate training, such as by requiring its drivers to practice locating and triggering the emergency remote shutoff in simulations, the driver might have attempted to trigger the emergency shutoff switch, rather than attempt to close the valve at the back of the trailer. Without adequate training, no amount of reading or checking would be likely to produce the appropriate response reliably in a real emergency.

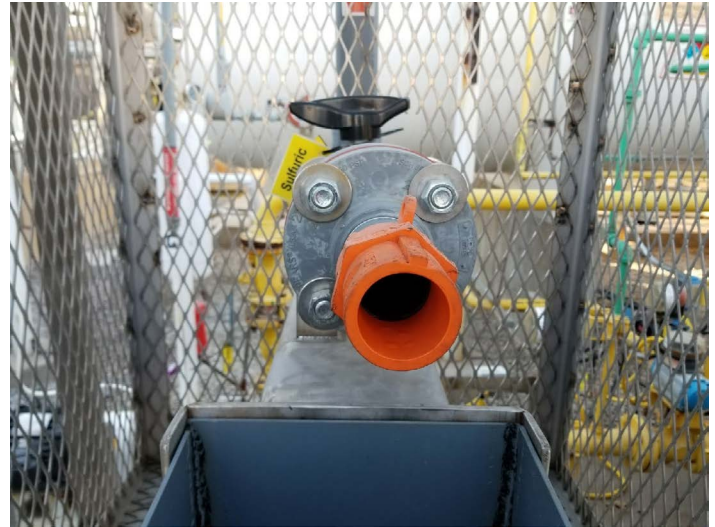
**Figure 18.** New coupling on the Mod B sulfuric acid fill line (Source: MGPI).

Immediately following the incident, MGPI made some temporary changes to its transfer equipment and unloading area to reduce the potential for a similar incident, until more permanent changes could be made. These included placing dedicated locks with separate keys on the different fill line caps, replacing the caps on the fill lines with caps that use a different locking mechanism, placing new (or more securely affixing existing) pipe markers closer to fill line connection points and elbows, placing new color-coded tags on the fill lines, and updating the chemical unloading procedures. Additionally, Harcros worked with MGPI to select and install new couplings on the Mod B

sulfuric acid fill line and Harcros sulfuric acid delivery hoses. These couplings share the same unusual size and shape, such that only the correct delivery hose can be connected to the sulfuric acid fill line. The couplings are also colored differently from all other couplings at the Mod B unloading area (Figure 18).
